25 May 2018

CRASH INCIDENT REPORT AND PROPOSED TREATMENTS FOR PENINSULA ROAD, VALLEY HEIGHTS

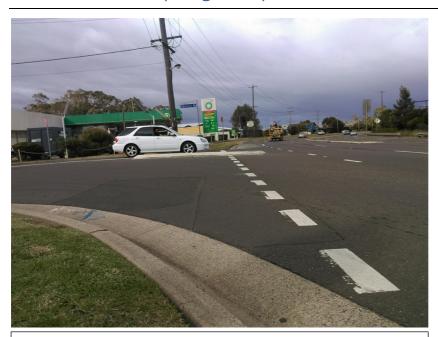
As RMS is aware, the concrete strip protrudes about 1.4 metres into the break down lane/ intersection (which is approximately half the width of the break down lane). The strip extends 1.4 metres in front of the stopping line for traffic turning left or right onto the GWH from Peninsula Road. No warning signs or line markings are present to alert cyclists of the median strip hazard. The GWH near Peninsula Road is a downhill section and riders are typically travelling at around 35-40km per hour as they approach the intersection where the median strip is located.

Photo 1 shows the median strip looking east.

In light of this crash the BMCSF requests RMS consider and implement alternative treatments to the median strip. Whilst we do not believe your options are limited to any particular number – we have prepared a proposed treatment for consideration.

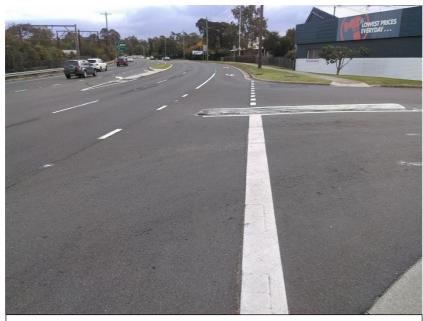
Photo 2 shows the median strip looking west.

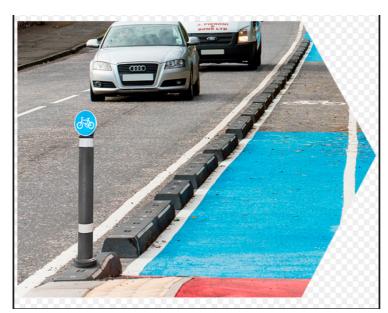
Photo 4 shows rubber blocks and bollards use to protect a bicycle only lane. We would emphasise that this is a critical control and without it the risk would significantly increase. Moreover, it is critical to overall

To further discourage vehicles from entering the intersection/bicycle lane, the shoulder, commencing from the BP side of Peninsula Road, should be turned into a dedicated bicycle lane for approximately 50 metres (eg enough to block the first driveway access but reform into a break down lane before the second driveway / exit. This could be achieved by narrowing the shoulder to 1.8 metres - 2 meters and placing rubber blocks on the lane edge (traffic side) to exclude other vehicles from the bicycle lane. Bollards may be used to signal the area is exclusively for bicycles and restrict other vehicle access (see photo 4 for an example). The bicycle lane should be painted with green pavement paint to enhance its status as a bicycle lane (eg not too thick as it can be slippery in wet conditions).

As noted above, the length of the corridor should be proximate to the start of the second drive way/ exit from BP (where it would taper back in alignment with the existing shoulder – at which point the blocks would terminate. This would permit vehicles to turn left from the BP back onto the GWH.
